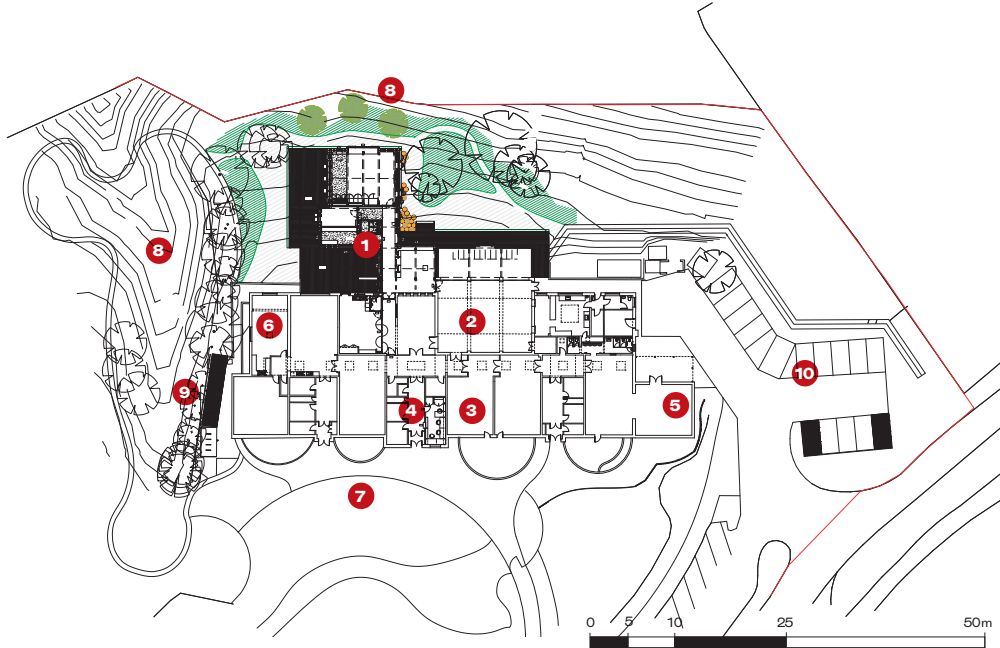
- 1** New block with terraces
- 2** Extended main hall
- 3** Existing south-facing classrooms
- 4** Reconfigured entrance/ admin
- 5** Nursery block
- 6** Staff room
- 7** Playground
- 8** Green belt scrubland
- 9** New bike sheds
- 10** Parking

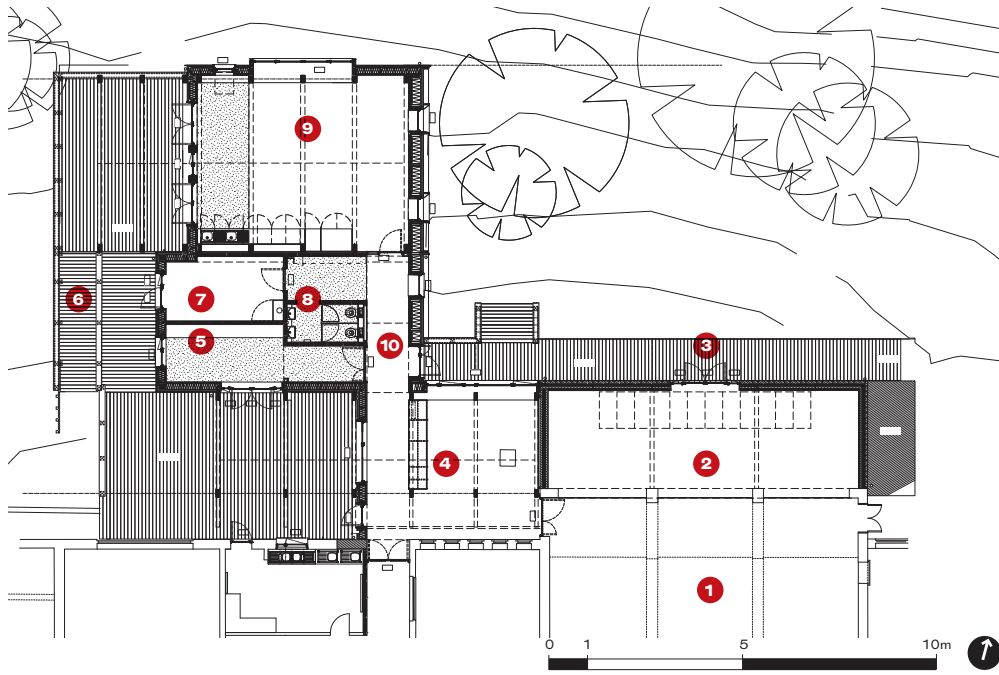
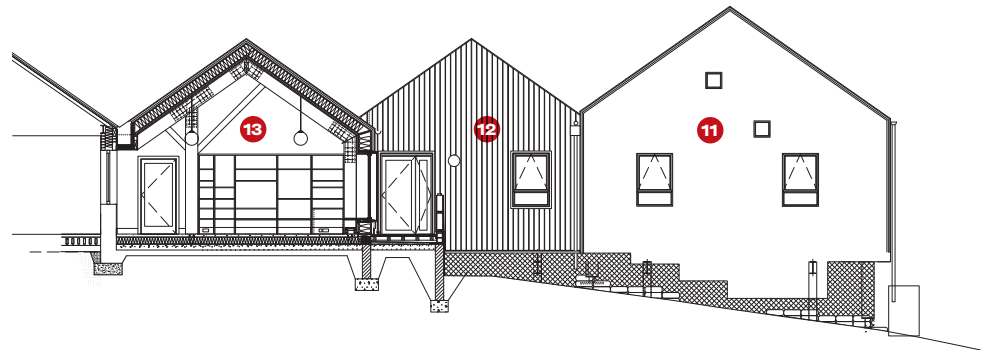
- 1** Existing main hall
- 2** New hall extension
- 3** North terrace
- 4** New library
- 5** Welly store
- 6** West terrace
- 7** One-to-one study rooms
- 8** WCs
- 9** New classroom
- 10** Corridor access to classroom
- 11** Habitat wall position
- 12** Cedar cladding
- 13** Library block
